Manhole Inspection Summary

Manhole # S61K__020MH

Location Address: **718 Rappolla St.**

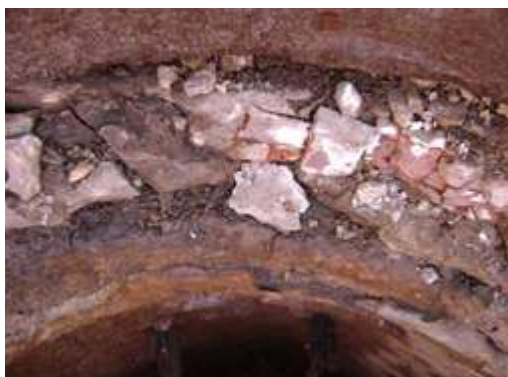
Defect 1

Condition: ☐ Sound ☐ Cracked ☐ Root Intrusion ☒ **Loose Brick** ☒ **Deteriorated**

Deterioration at chimney

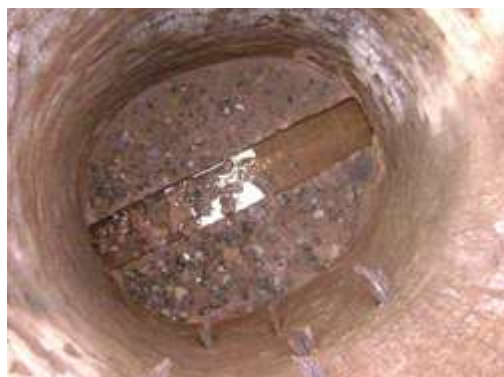
Defect 2

Condition: ☐ Sound ☐ Cracked ☐ Root Intrusion ☐ Deteriorated ☐ Leaks ☒ **Debris**

Debris on bench

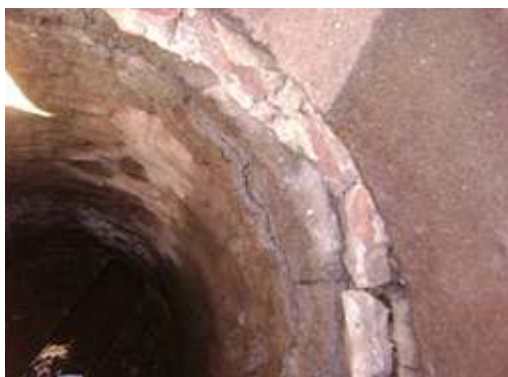
Defect 3

Infiltration: ☐ None ☐ Joint ☐ Cracks ☒ **Mortar** ☐ Roots ☒ **Wall**

Infiltration

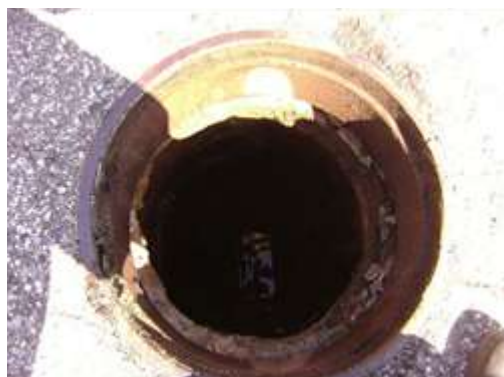
Defect 4

Frame Offset: **2** (in.) Condition: ☒ Sound ☐ Cracked ☐ Leaks

Frame offset defect

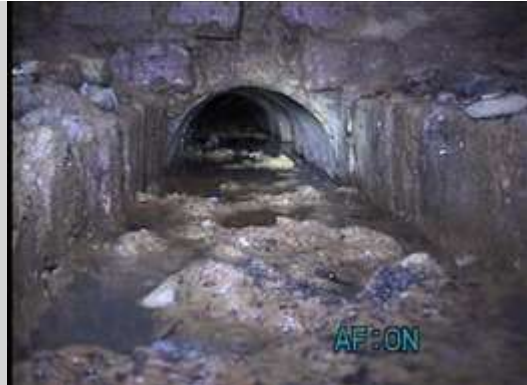
12 O'Clock Outflow

Pipe Height: **8.4** (in.) Rod and Bar (Angled)
Pipe Material: **Clay** ☐ Pipe Lined
Invert Depth: **8.00** (ft.) Flow Characteristics: **Slow**
Deposits: ☐ None ☐ Mud ☒ **Sludge** ☒ **Debris** ☐ Grease
Silt Depth: **2** (in.) Deposits Extent: **Medium**
Infiltration: **None** Pipe Seal Cond: **Sound**

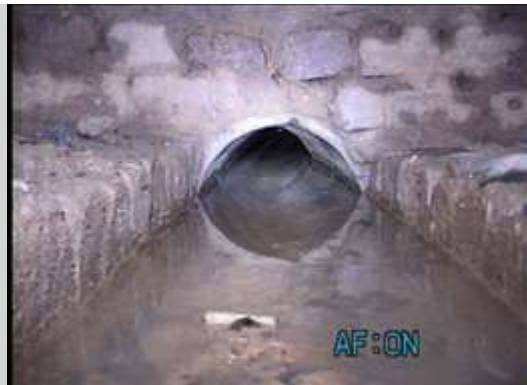
6 O'Clock Inflow

Pipe Height: **8.4** (in.) Rod and Bar (Angled)
Pipe Material: **Clay** ☐ Pipe Lined
Invert Depth: **7.96** (ft.) Flow Characteristics: **Slow**
Deposits: ☐ None ☐ Mud ☒ **Sludge** ☐ Debris ☐ Grease
Silt Depth: **1** (in.) Deposits Extent: **Light**
Infiltration: **None** Pipe Seal Cond: **Sound**
